# **Storm Drain Study**

# STORM DRAIN INSPECTION REPORT FOR:

# VA Northern California Healthcare System Alameda Point, CA

March 8, 2016

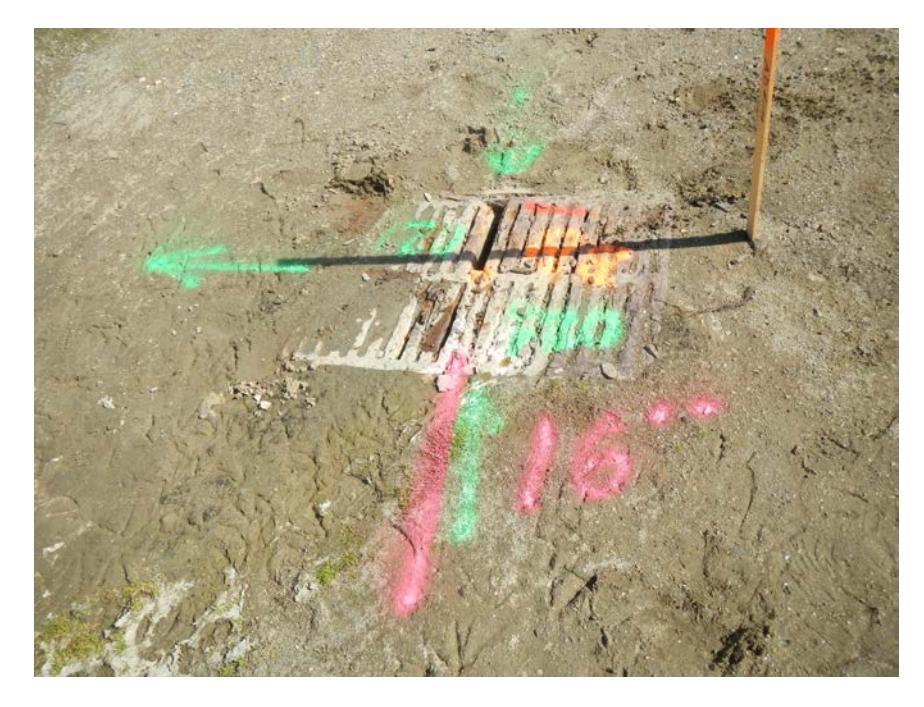
Structure: 7-21

1.) <u>Rims on Catch Basins were rusted shut</u>. Due to age and deterioration, several rims were inoperable and rusted shut to the frame of the inlet. To mitigate this condition, the rims would have to be forcefully removed which would likely break them so if this was attempted the owner should be prepared to replace the rims and/or catch basins if intended for future use. A photo of this condition is shown below.

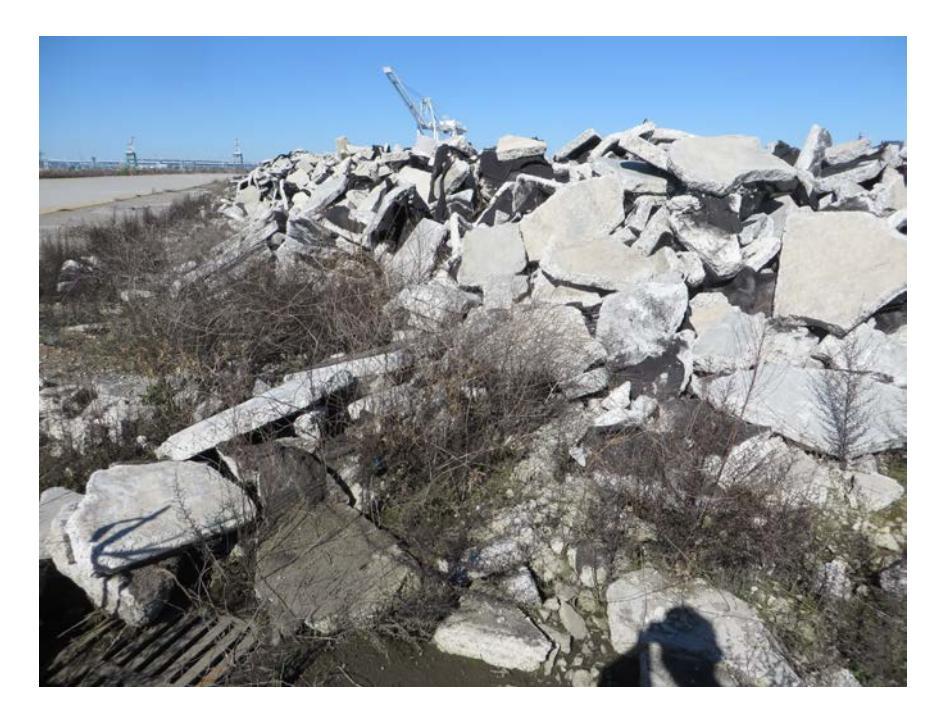
2.) Inlets or Manholes were buried or otherwise covered. In locations where inlets were expected to be, debris piles, trench plates, dirt, or overgrowth were present so the storm drain pipe could not be inspected. In cases where debris or other material can be removed or relocated it is possible that the inlets could be located and inspected but it is unlikely they would be found if buried. Photos of this condition are shown below.

Structure 2-10 shown. Structure 2-06 not located.

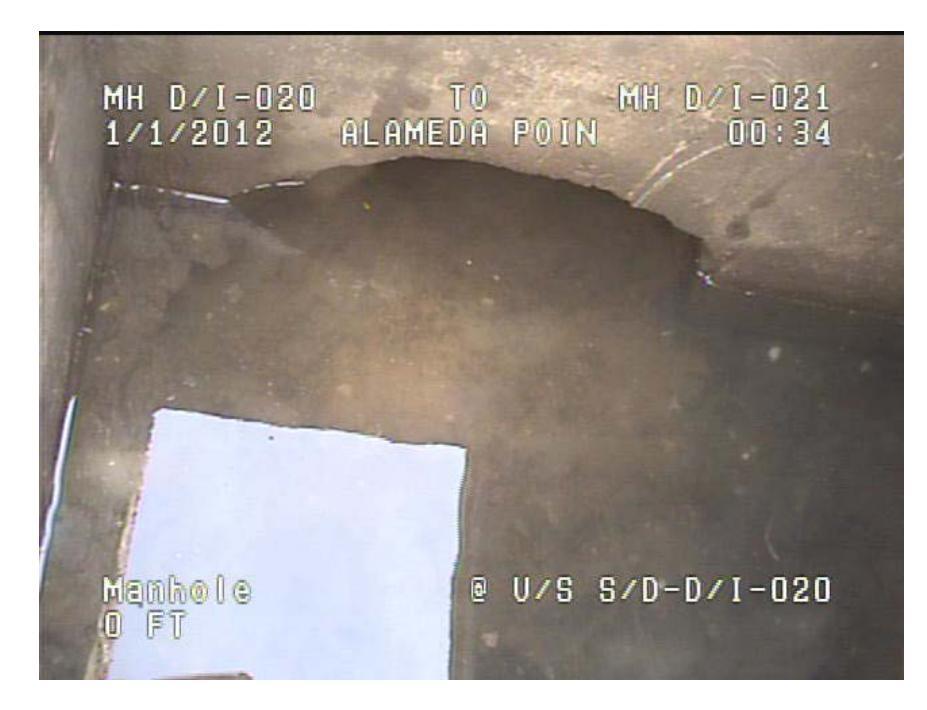
Subdynamic Survey (2016) - Structure 7-20 to 7-21

3.) <u>High Water Level encountered in pipes</u>. As mentioned previously, the work was timed with the low tide to best mitigate this issue. However, in several locations high water level prevented the completion of a portion or entirety of a storm drain pipe. It is possible that the pipes are clogged downstream and water is not being released which is creating this condition. To fix this issue, we recommend the water be pumped out and the pipe be cleaned or repaired as needed. A photo of this condition is shown below.

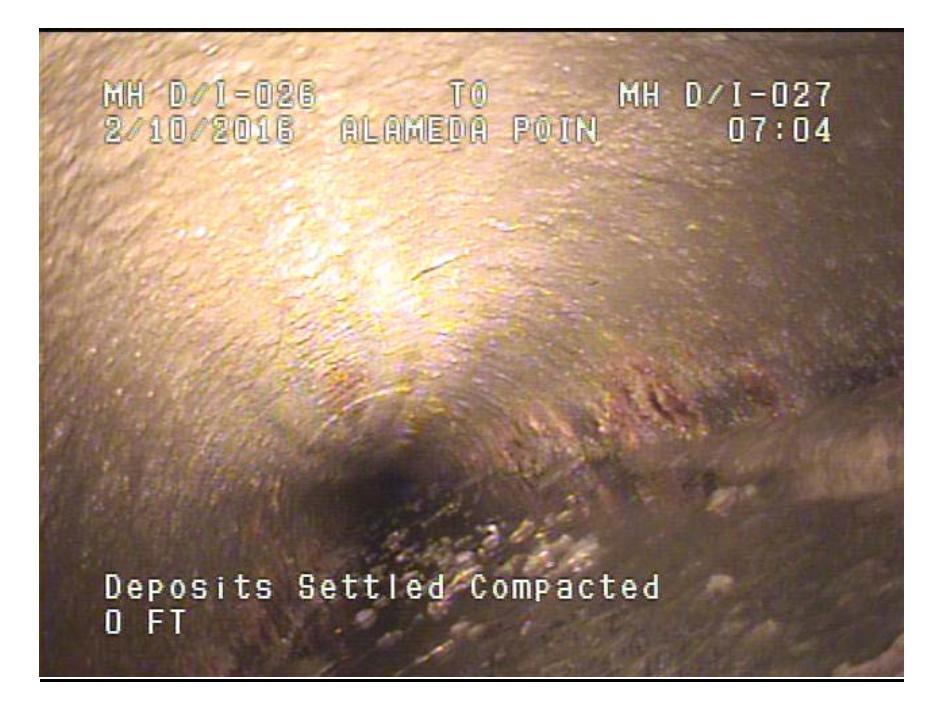
Subdynamic Survey (2016) - Structure 8-26 to 8-27

4.) <u>Silt, Sediment, or Debris clogging pipe</u>. This was the most common problem and prevented completion of the video inspection in the majority of the pipe on this site. This issue can be mitigated by hydrojetting or vacuum cleaning the pipes in order to re-attempt the video inspection. In some cases portions of the pipe may need to be physically removed in order to complete the video inspection. Photos of this condition are shown below and seen in the videos that were performed.

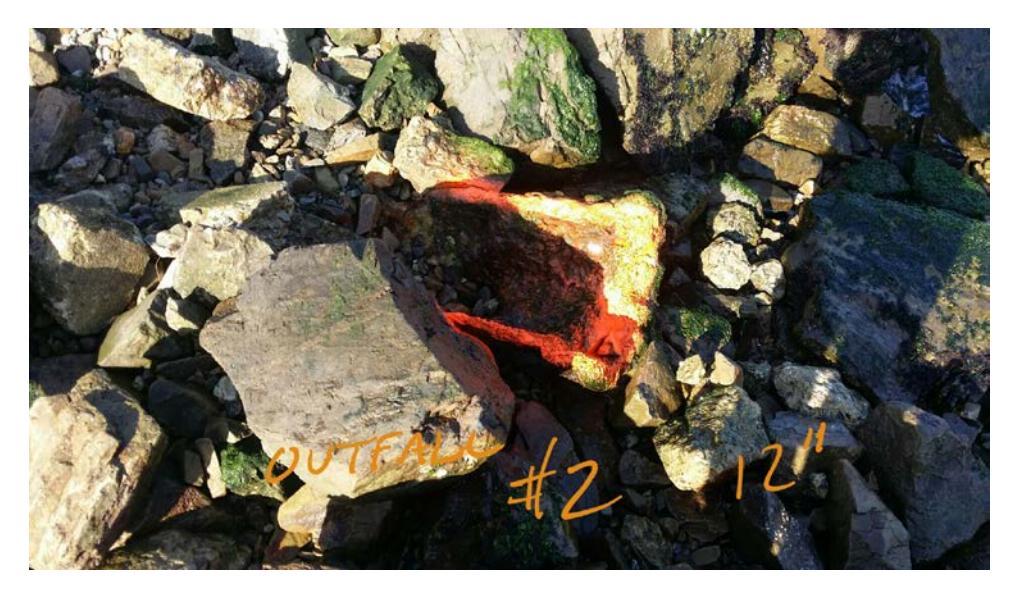
OUTFALL 2

Size and Material:12" Corrugated Metal PipeCondition:Bottom half of pipe found eroded and rusted. Rocks blocking<br/>outfall pipe upstream.Suitability for Reuse:Outfall is not suitable for reuse.
